ATTACHMENT 5

INITIAL INVESTIGATION

**FACT FINDING INVESTIGATION
CONCERNING LOW POTASSIUM
ACTIVITY CONCENTRATIONS FOUND
IN SOIL SAMPLES FROM WITHIN THE
BUILDING 517 AREA**

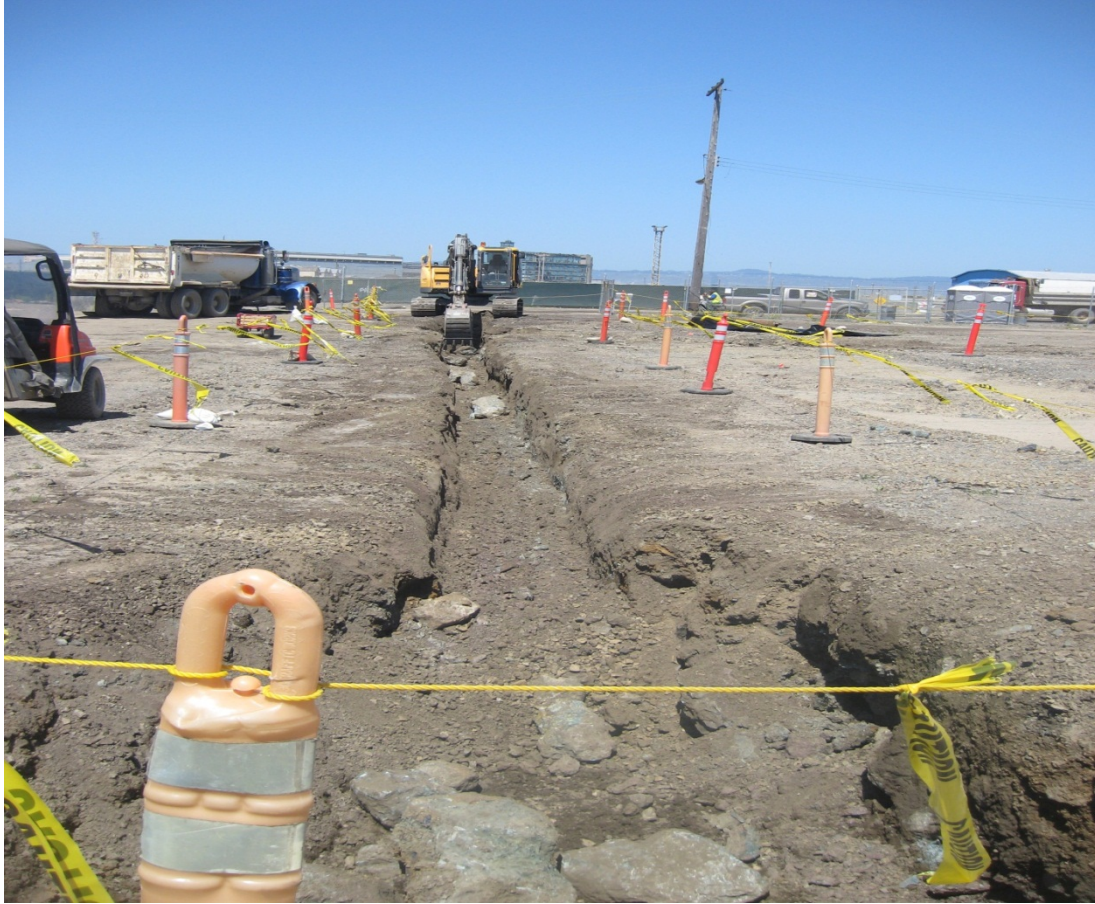
Figure 1. Trench Unit 305 running along the northwest border of Survey Unit 2. Serpentinite boulders shown.

The Professional Field Engineer: This engineer laid out the sample points. He and his co-engineer both verified that serpentine rock was prevalent on the surface and in the subgrade of SU-002 and the surrounding area. He recalls sample points in this location excavated to a depth of about 18 inches when a backhoe was used. Both engineers recall a serpentine stratum (layer of fill) in Trench Unit 305, which borders the west side of SU-002 and enters the north end—they supplied a photo (see Figure 1) and map (see Figure 2).

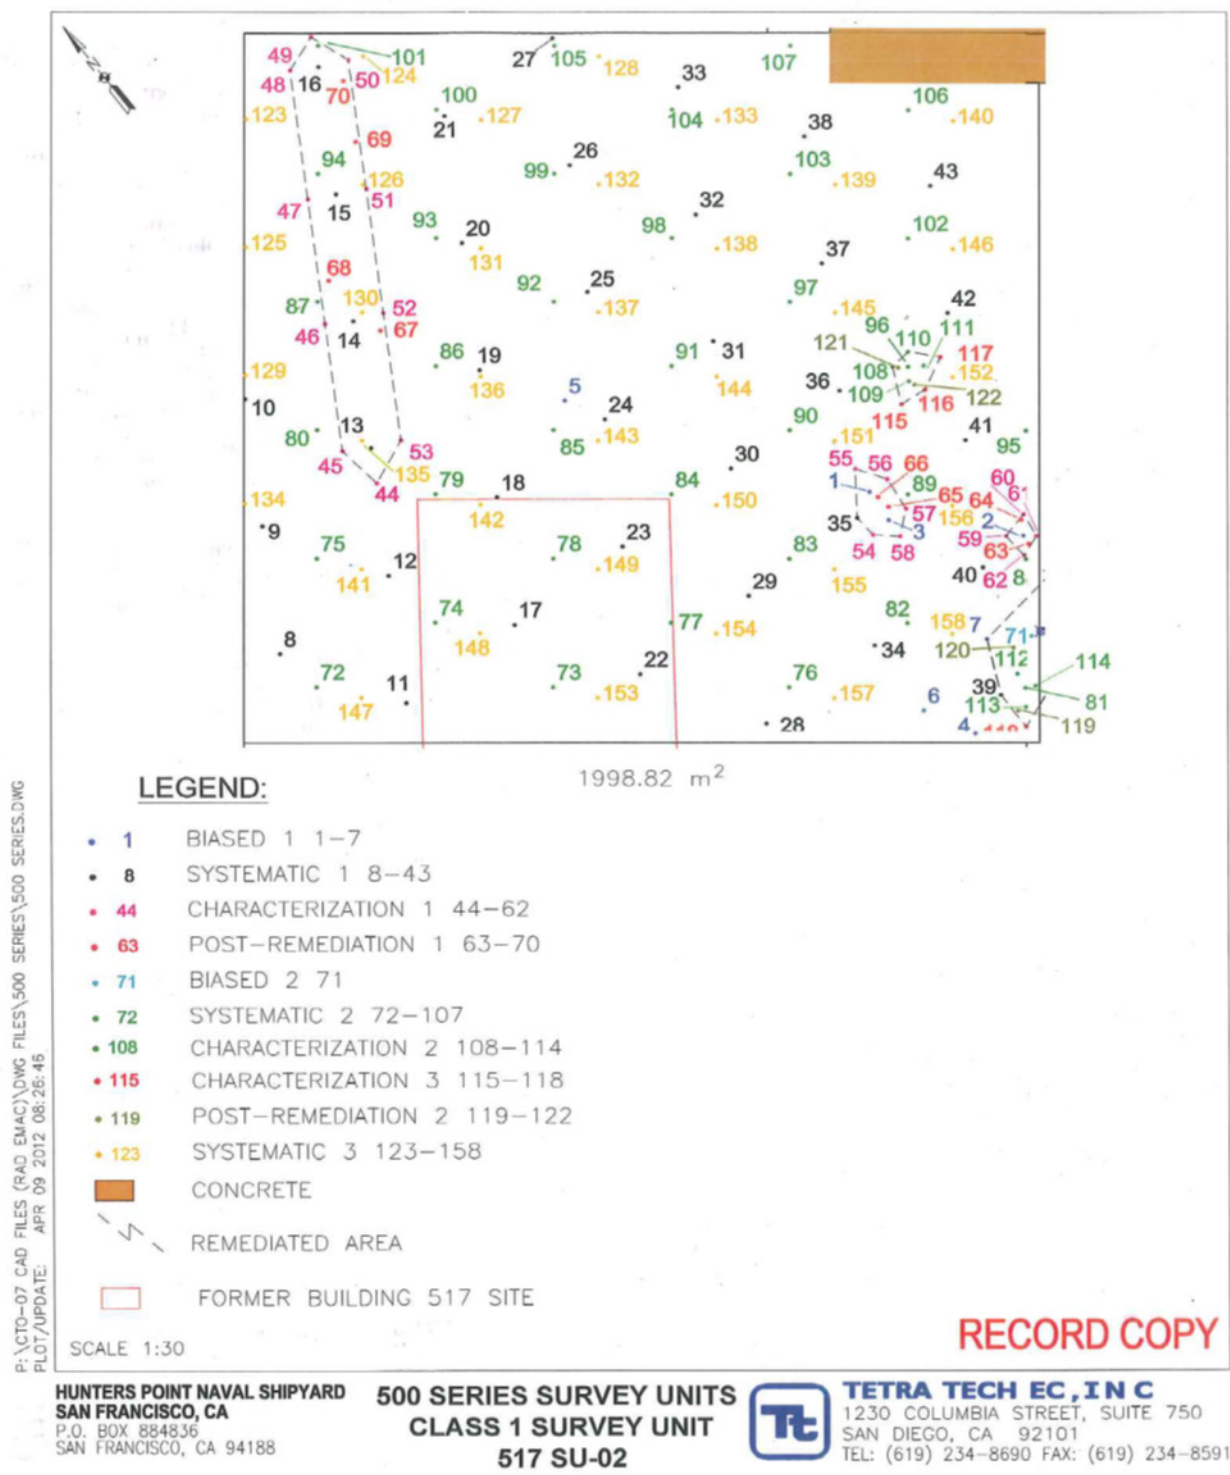
Figure 2. Map showing Trench Unit 305 running along the northwest border of Survey Unit 2.

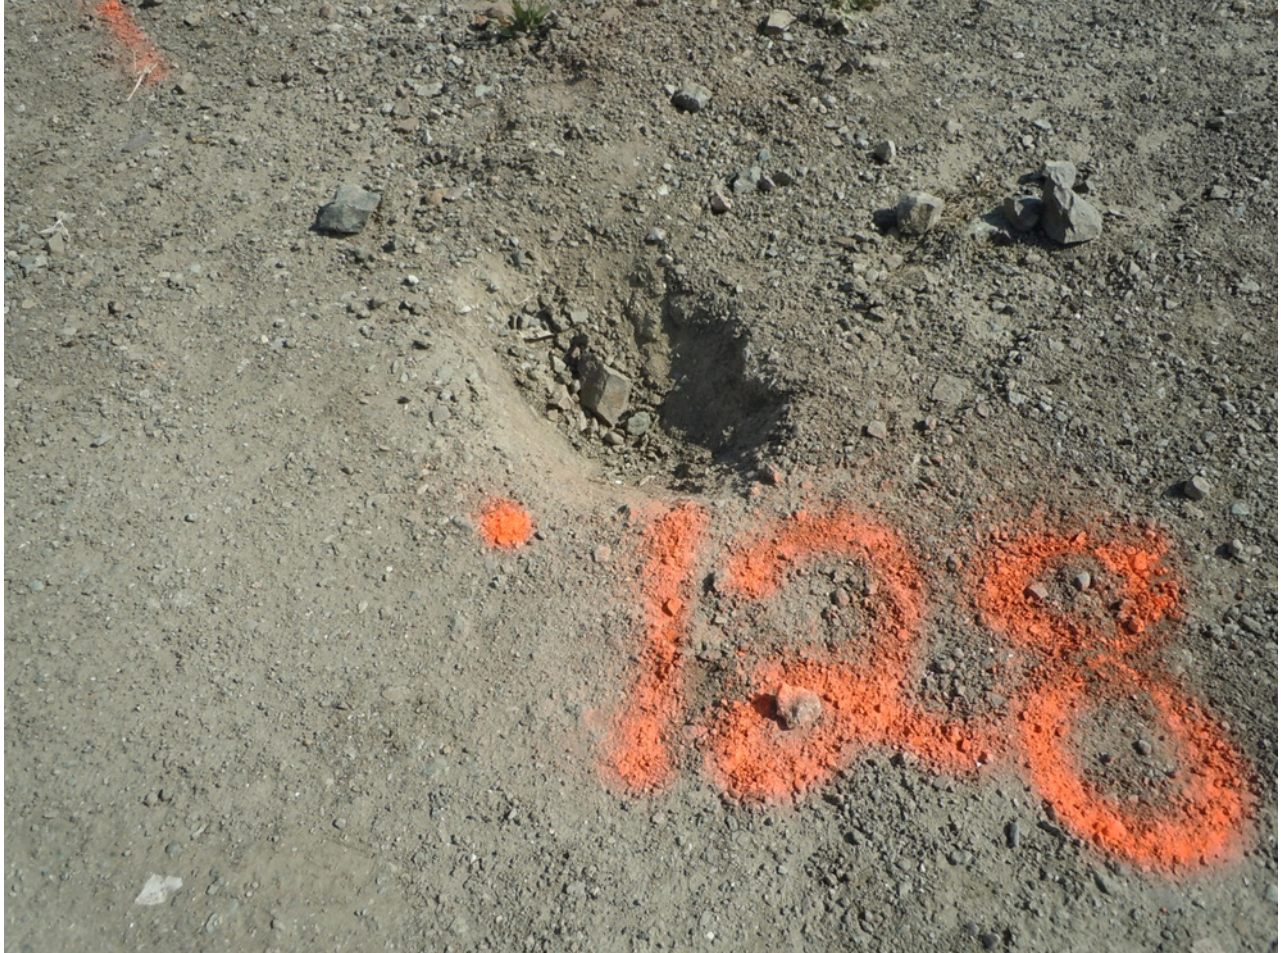
The PQCM: Brought a fox tail brush to Survey Unit 2 and brushed off a few of the existing sample locations (many original locations had been tracked over by heavy equipment) to expose what was under the dust. The existing sample points looked like 2-foot-diameter bowls in the ground with spoils on the side as shown in Figures 3, 4, 5, 6, and 7.

Figure 3. Sample location #128 from SU-002 after brushing.

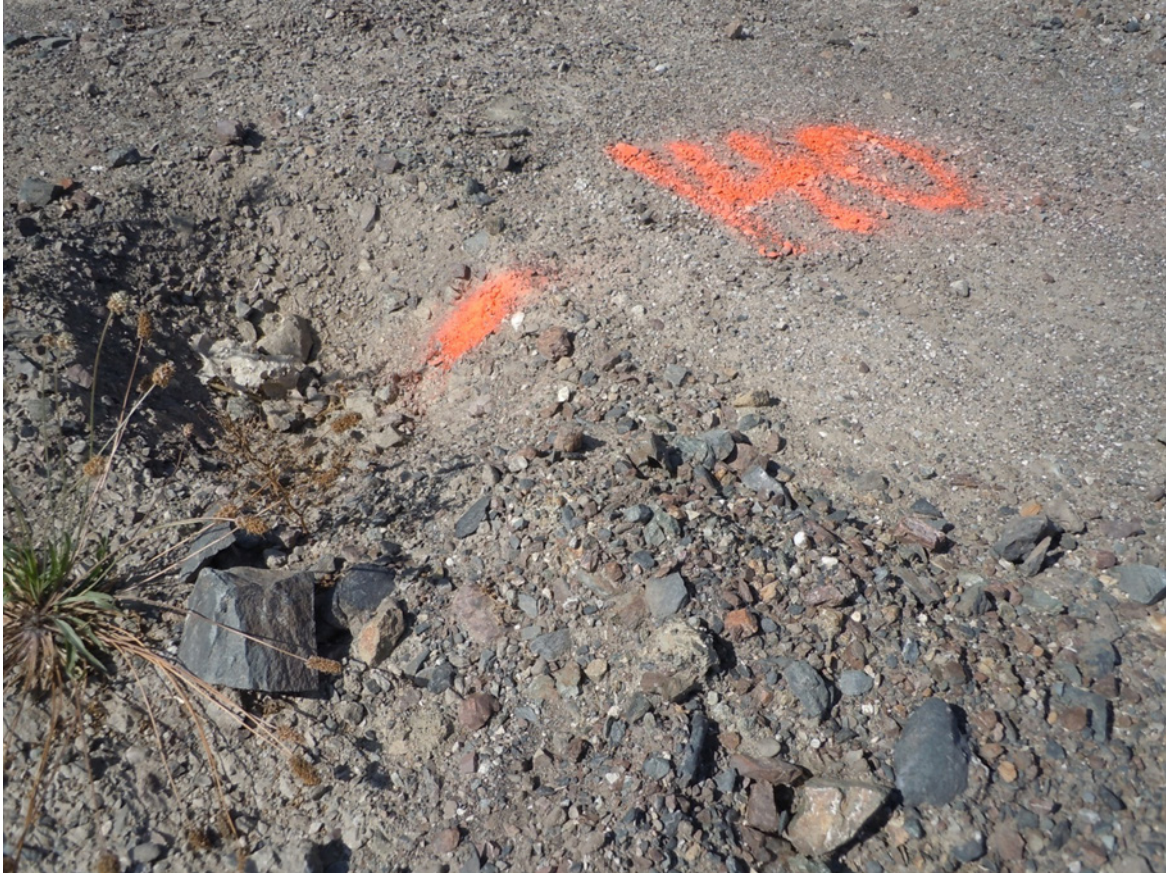
Figure 4. Sample location #140 from SU-002 after brushing.

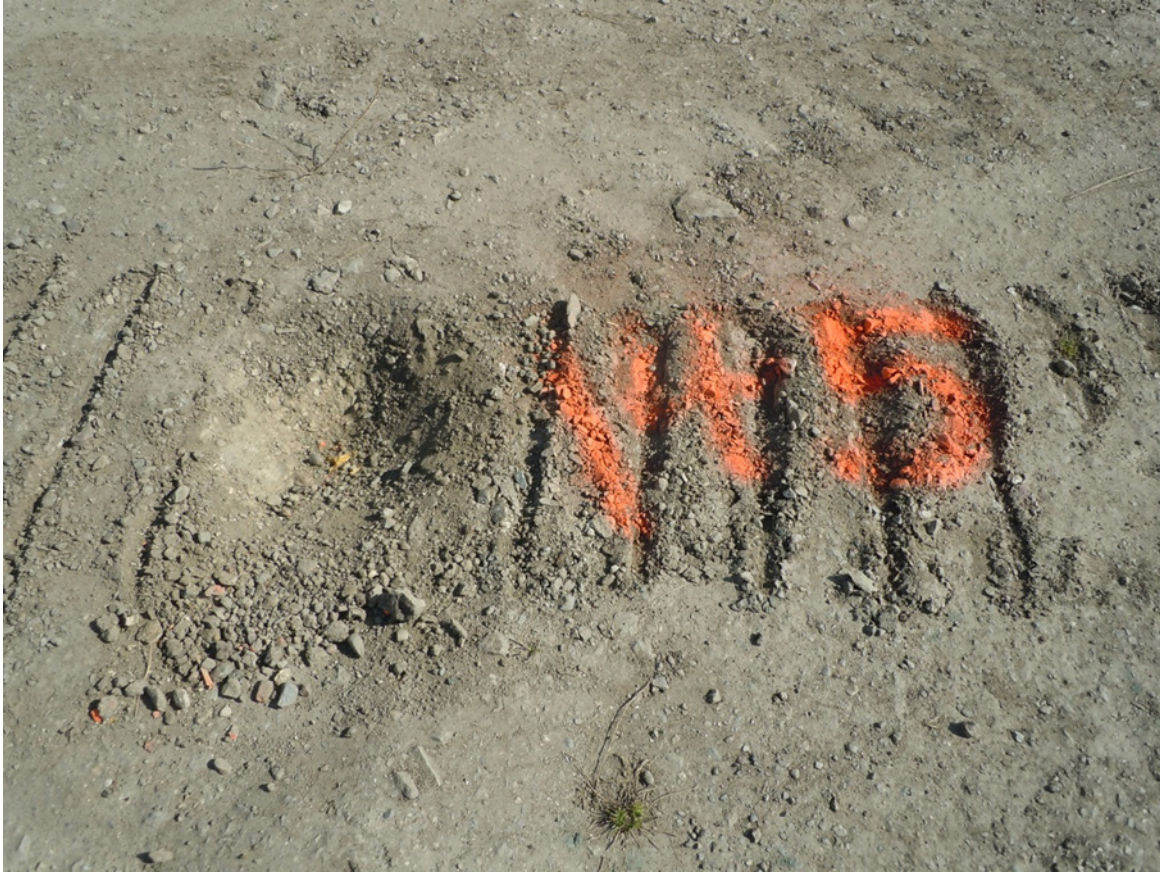
Figure 5. Sample location #145 from SU-002 after brushing.

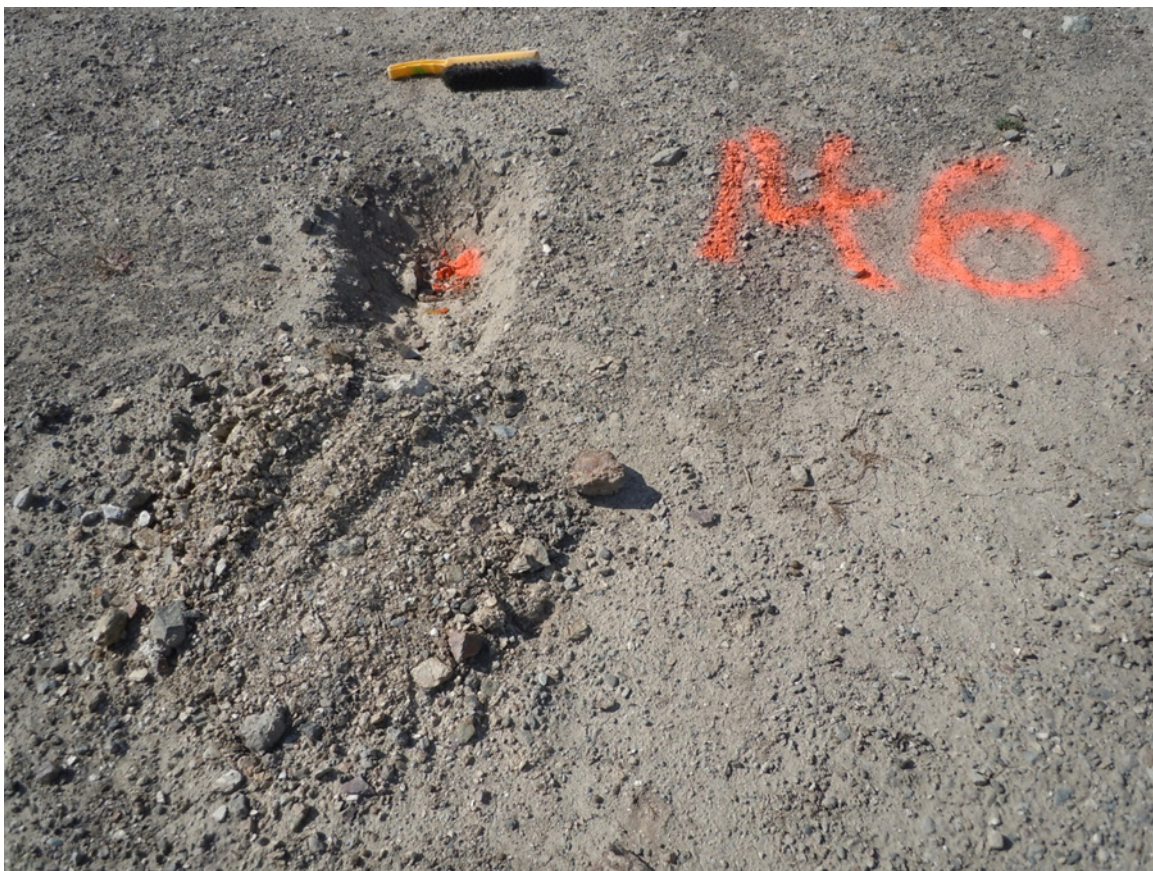
Figure 6. Sample location #146 from SU-002 after brushing.

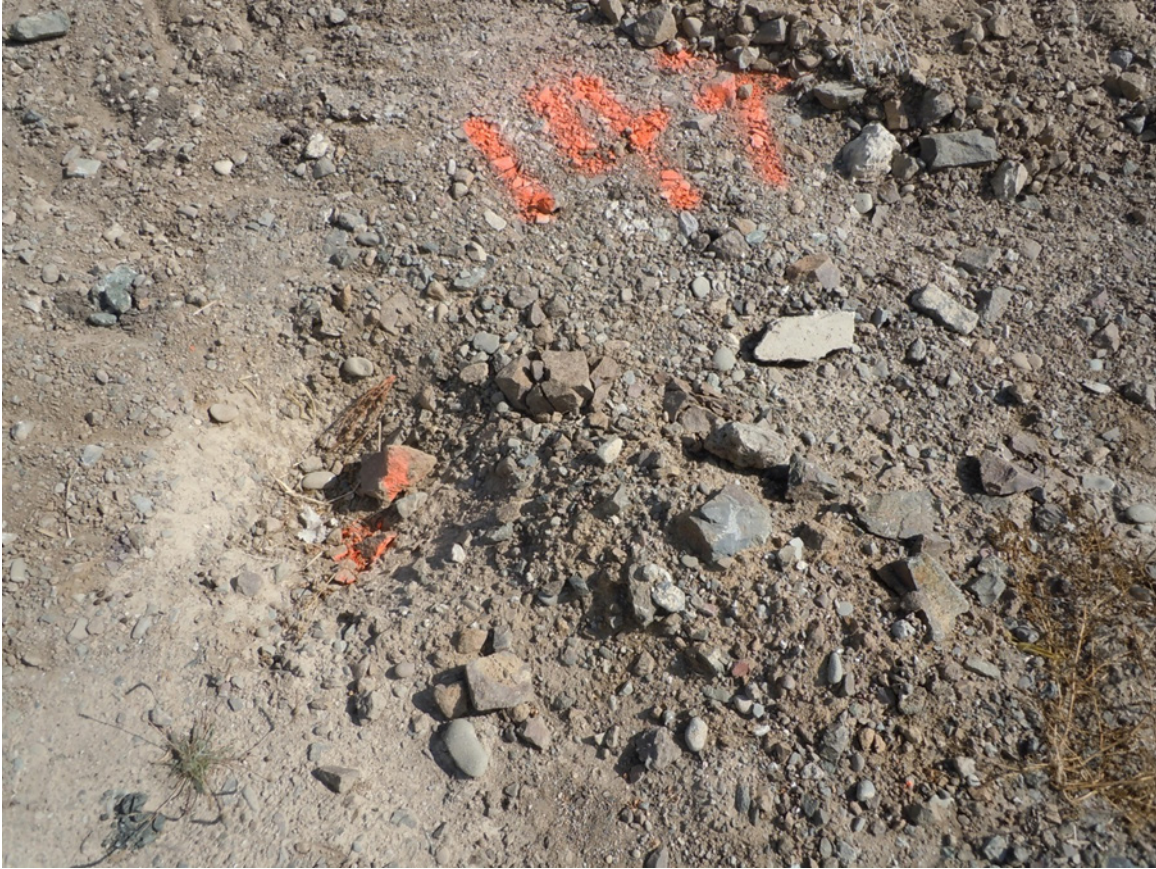
Figure 7. Sample location #147 from SU-002 after brushing.

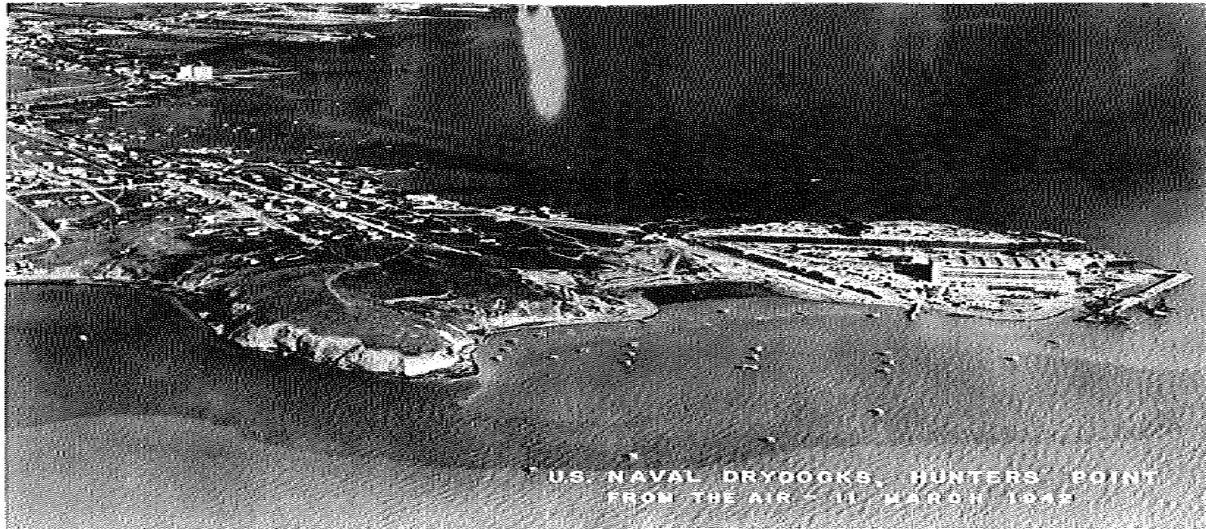
Figure 8. U.S. Naval Photo, 1942, showing hillside and underwater geological formation.

In the late 1930s and early 1940s fill was used to create the Parcel E land surface beyond the historic shoreline at HPNS (Figure 8). This fill ranged from silty and sandy clays with gravel to poorly graded sands, boulders, and debris deposits. A majority of the coarse fill material was locally derived from the Franciscan Formation bedrock consisting of serpentinite, greenstone, shale, greywacke, and chert. In addition, during the creation of Parcel E by filling in South Basin, the island of Shag Rock was incorporated into HPNS (Figure 9). This remnant island also is made of up Franciscan Formation material.

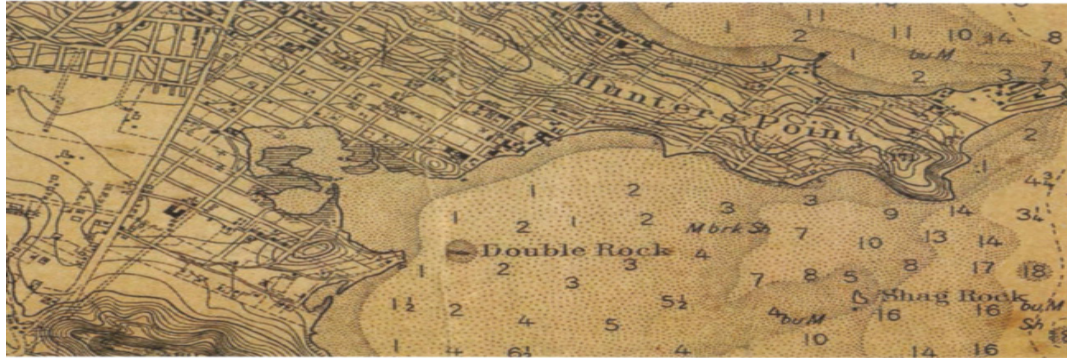
**Figure 9. Nautical Map, 1907, showing Shag Rock location and depth in feet (MSL).
As shown, buM represents blue mud as referenced from this map's key.**

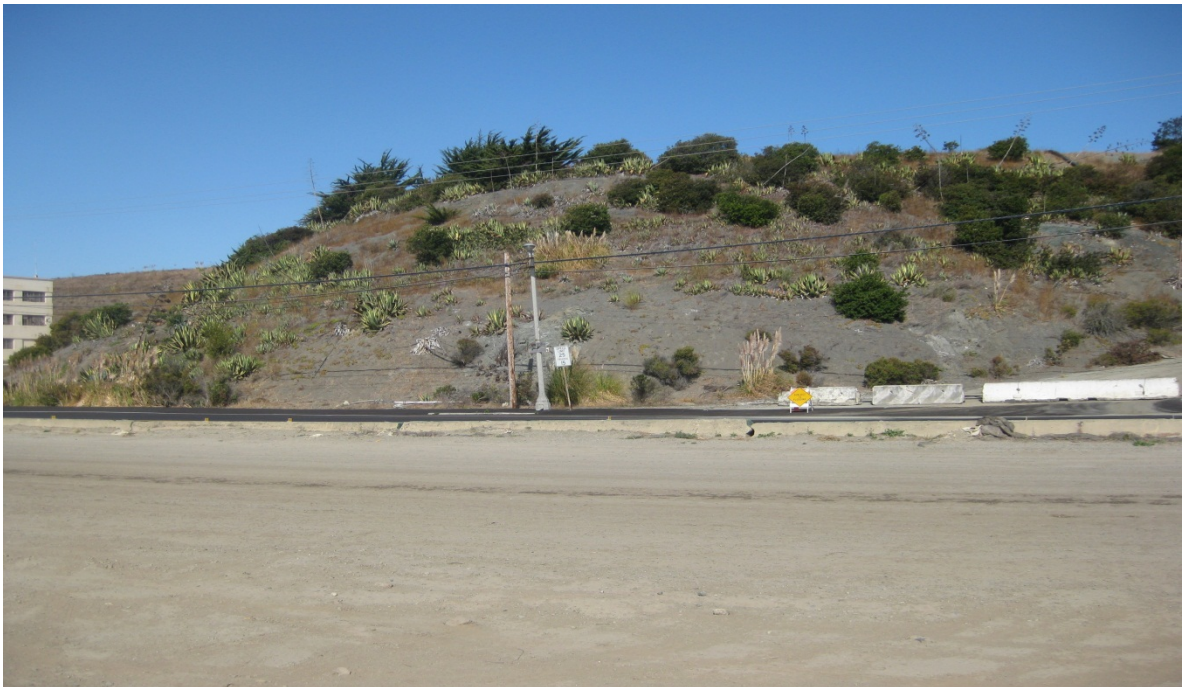
The bedrock or bedrock material used as fill material encountered within Parcel E consists mostly of metamorphic basalt called “greenstone” and serpentinite. Competency of the bedrock material at Parcel E ranges from low to very hard, and fractures are common. The weathered material has low hardness, crumbles easily to sand-sized grains, and is friable. The unweathered serpentinite is hard and fractured (Figure 10).

Figure 10. Serpentine slope at HPNS. Plant varieties are quite limited.

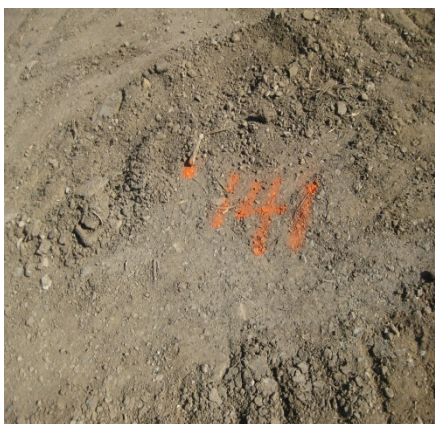
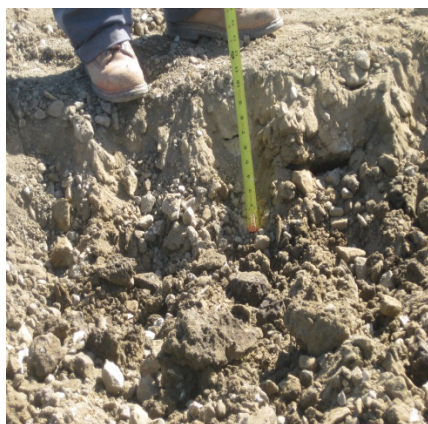
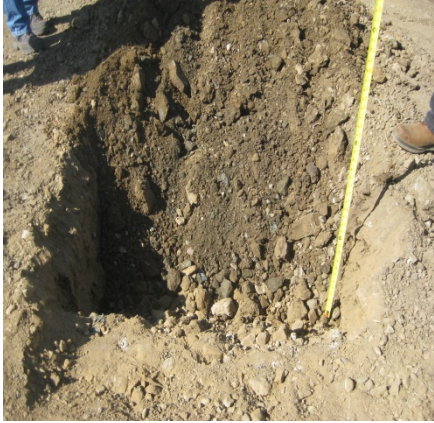
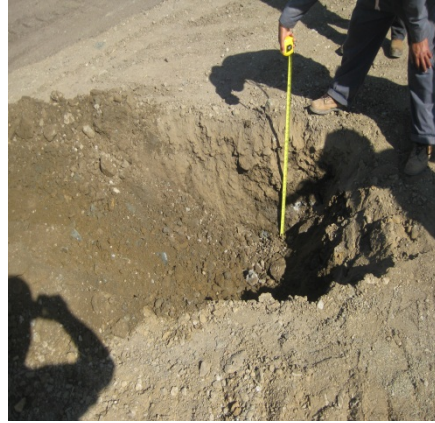
Potholes were excavated at sample locations #141, #148, #149, and #155 with heavy equipment to identify geological material type and depth. Excavation at each location was performed in 6-inch lifts, with photos and measurements being taken between lifts (See Figures 11 through 29). A geologist was present to aid in the identification of subgrade material types.

Figure 11. Sample location 141 at grade.

Figure 12. Sample location 141 at 1'.

Figure 13. Sample location 141 at 2'.

Figure 14. Sample location 141 at 3'.

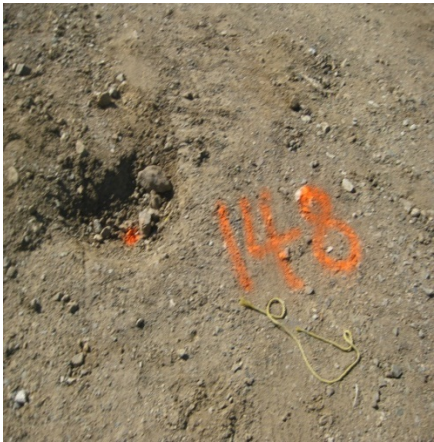
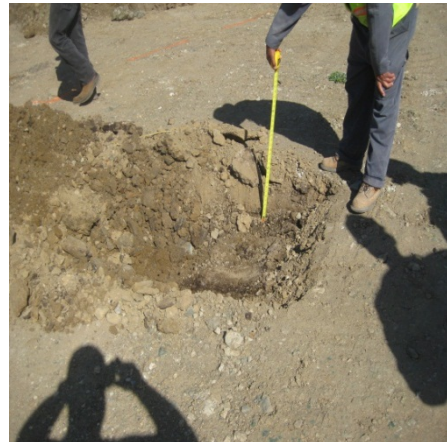
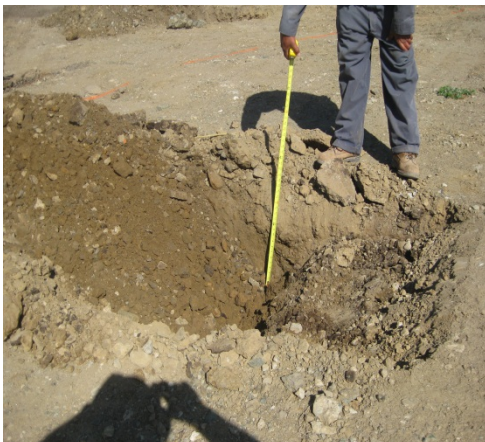
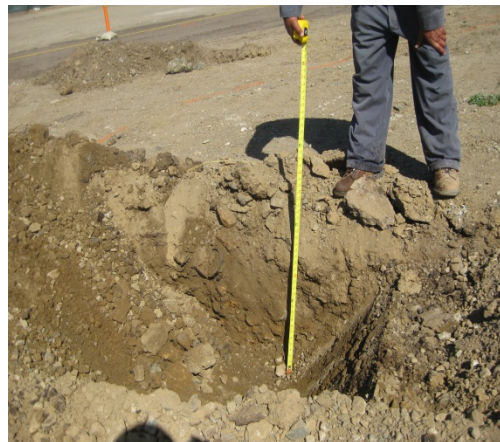
Figure 15. Sample location 148.

Figure 16. Sample location 148 at 1'.

Figure 17. Sample location 148 at 2'.

Figure 18. Sample location 148 at 3'.

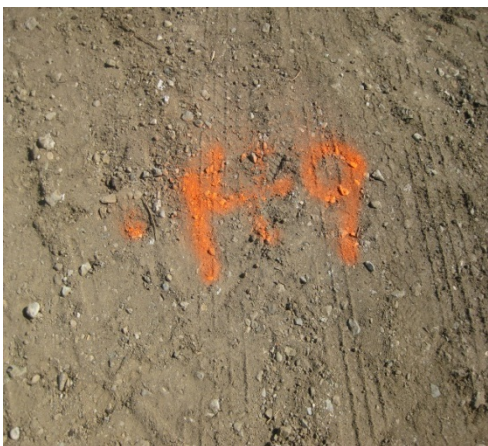
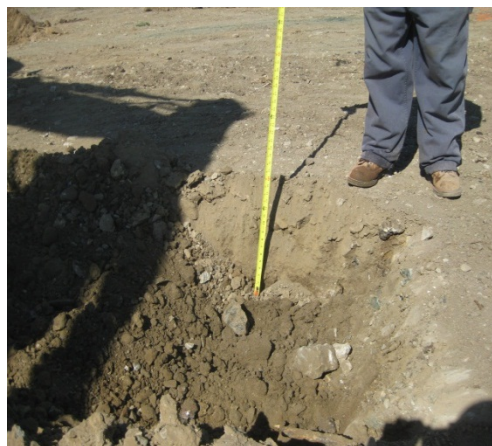
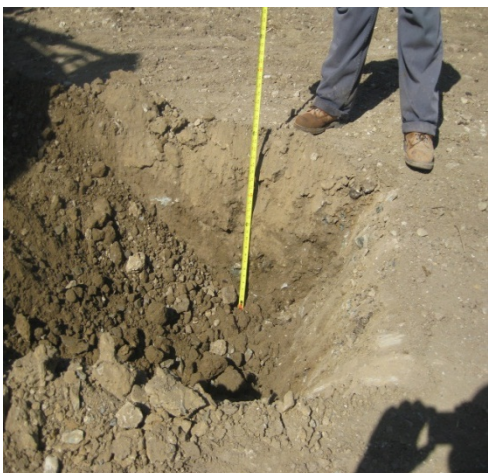
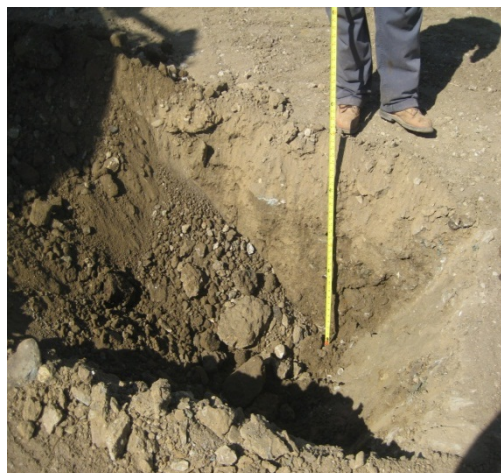
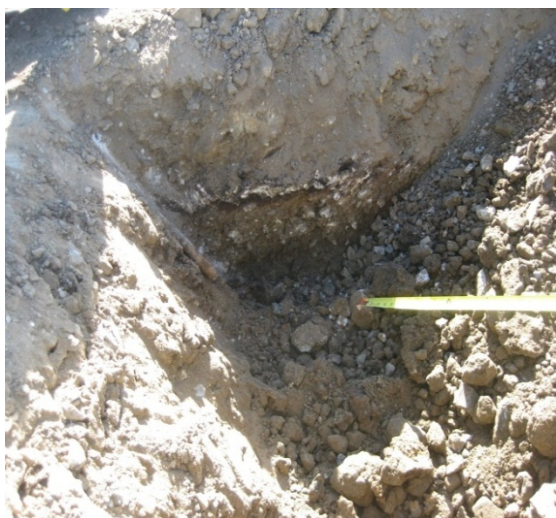
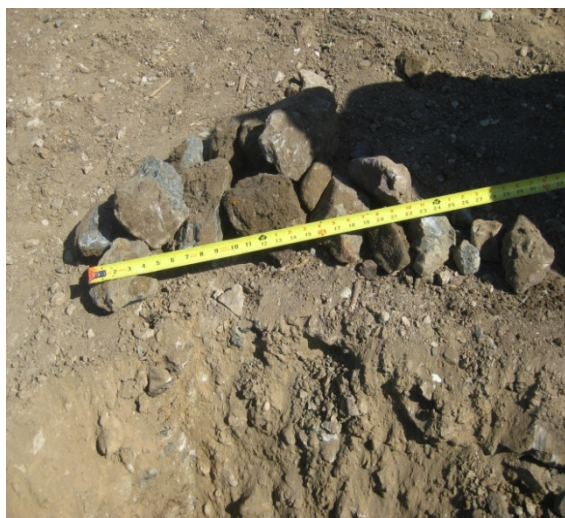
Figure 19. Sample location 149.

Figure 20. Sample location 149 at 1'.

Figure 21. Sample location 149 at 2'.

Figure 22. Sample location 149 at 3'.

Figure 23. Sample location 149 bottom of hole.

Figure 24. Sample location 149 cobbles found.

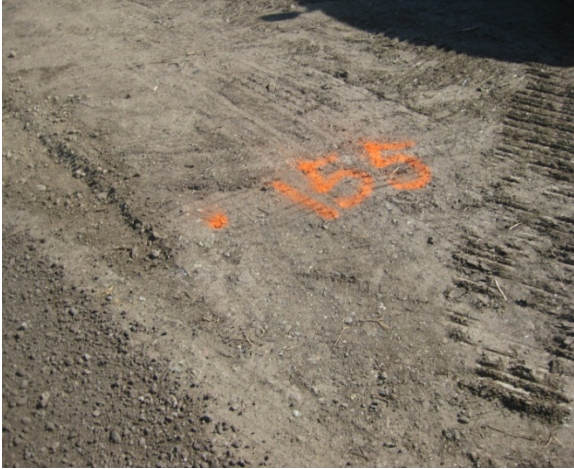
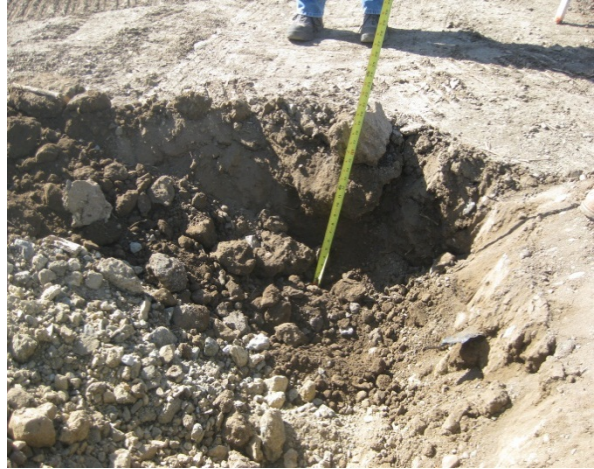
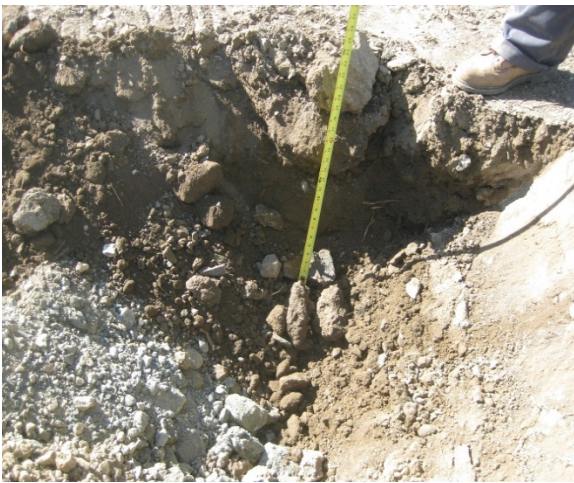
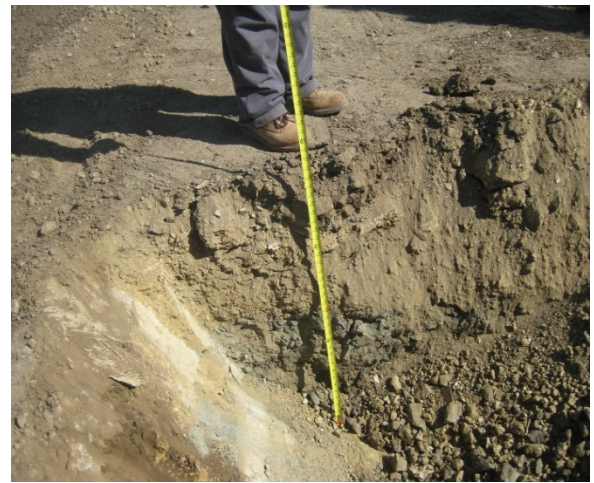
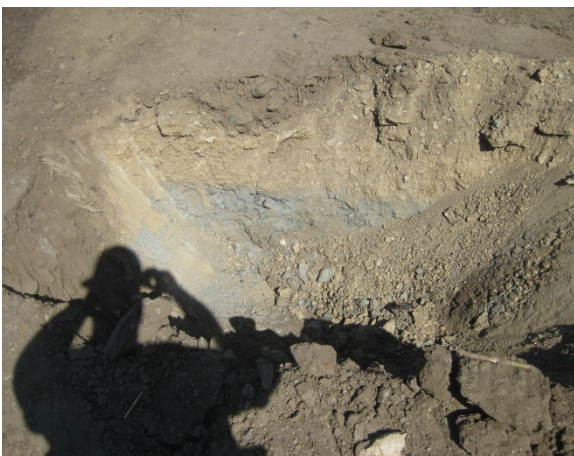
During the pothole study at locations #141, #148, #149, and #155 within B-517/SU-002, various colors of native soil and backfill were observed that are consistent with subsurface soils typically encountered at Parcel E. The test pits were dug to a depth of 3 feet below ground surface and the material encountered was consistent with materials derived from the Franciscan Formation: weathered to unweathered serpentinite and greenstone in a clay/silt matrix mixed with a variety of sandstone and siltstone fragments. This is what would be expected either from the use of bedrock material as fill material or due to excavation in the proximity of the Shag Rock Island bedrock fragment.

Figure 25. Sample location 155.

Figure 26. Sample location 155 at 1.5'.

Figure 27. Sample location 155 at 2'.

Figure 28. Sample location 155 at 3'.

Figure 29. Sample location 155 serpentinite lens shown.

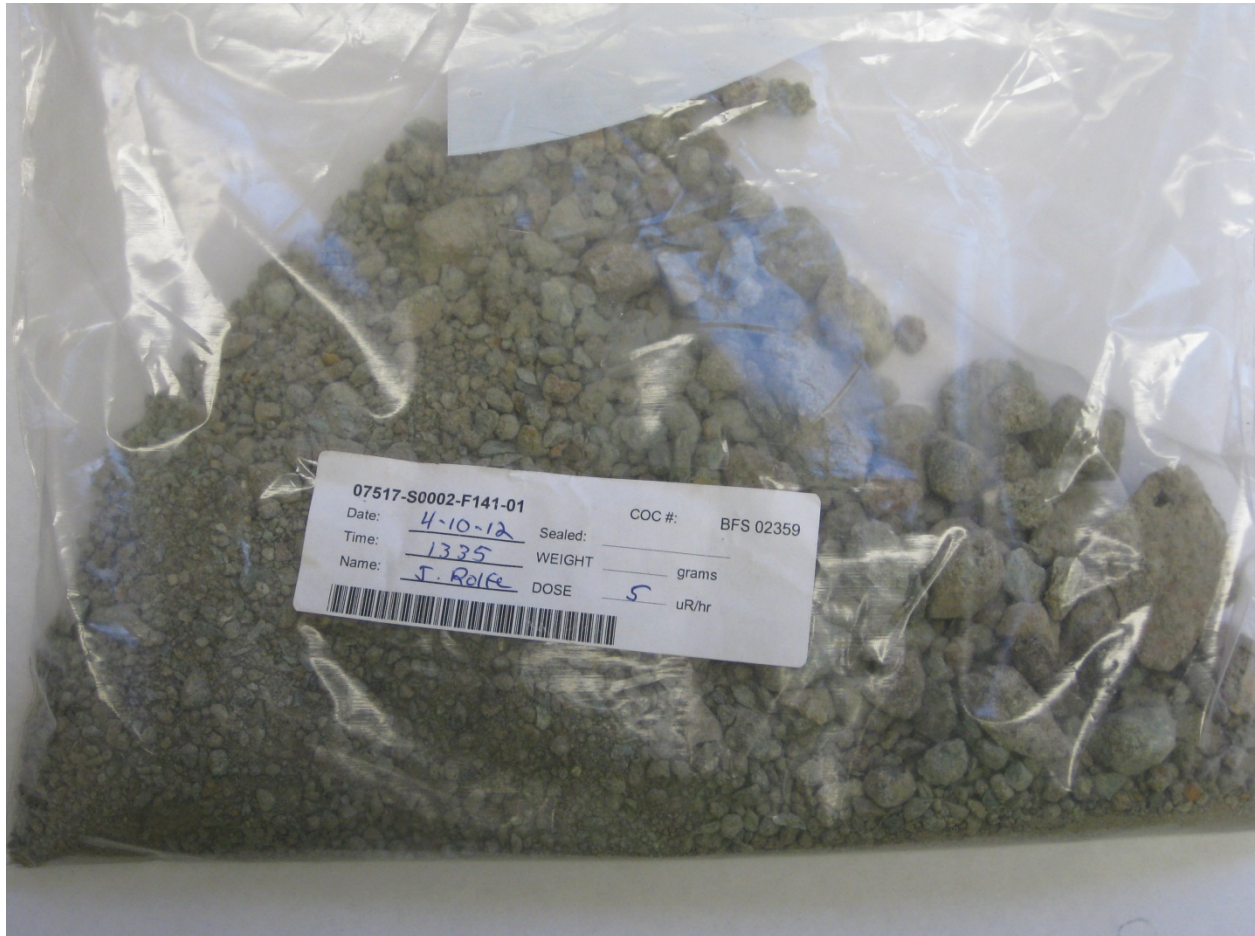
Figure 30. Sample #07517-S0002-F141-01.

Left over sample media from locations #141, #148, #149, and #155 (the same locations where investigative potholes were excavated) were photographed. See Figures 30, 31, and 32.
